Thursday, October 10, 2024: 4:00 PM

Historic District Commission

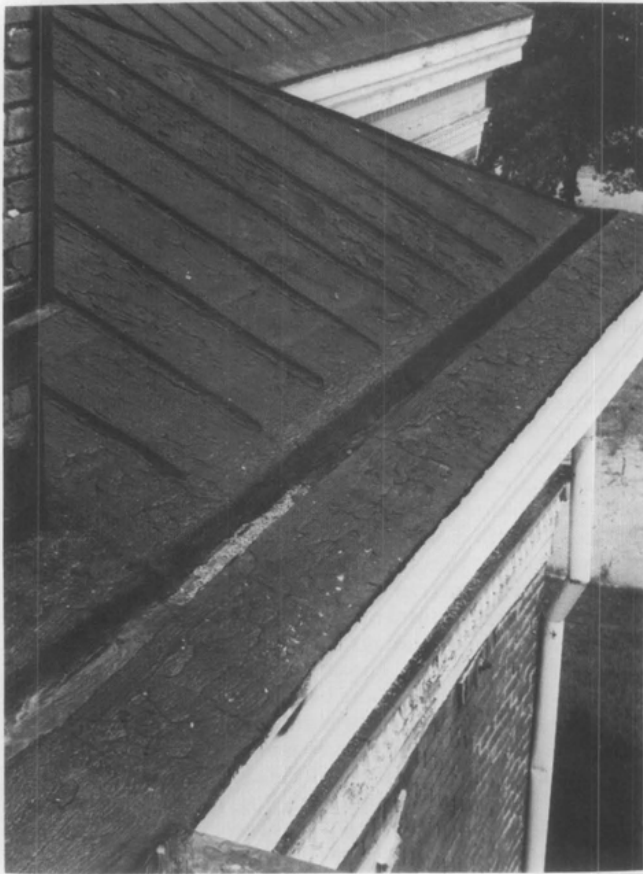
Repeated repair with asphalt, which cracks as it hardens, has created a blistered surface on this sheet-metal roof and built-in gutter, which will retain water. Repairs could be made by carefully heating and scraping the surface clean, repairing the holes in the metal with a flexible mastic compound or a metal patch, and coating the surface with a fibre paint. (Roane County Courthouse, Kingston, Tennessee, photo courtesy of Building Conservation Technology, Inc.)

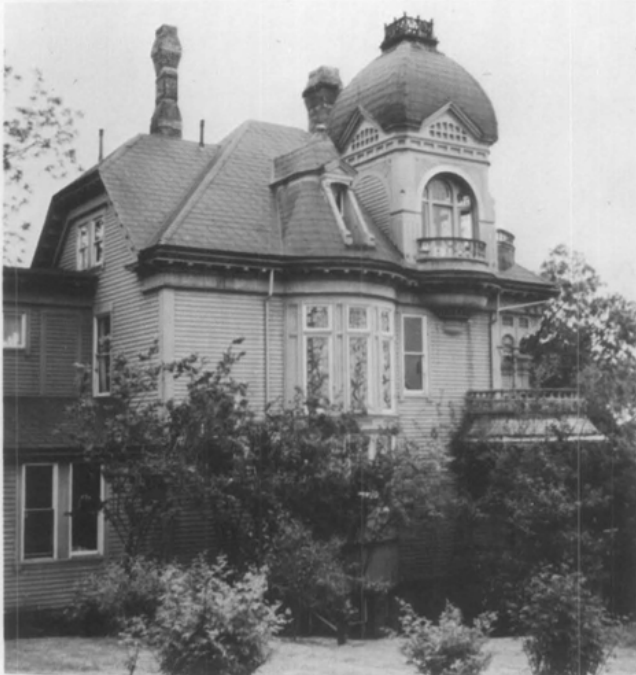
Special problems inherent in the design of an elaborate historic roof can be controlled through the use of good materials and regular maintenance. The shape and detailing are essential elements of the building's historic character, and should not be modified, despite the use of alternative surface materials. (Gamwell House, Bellingham, Washington)

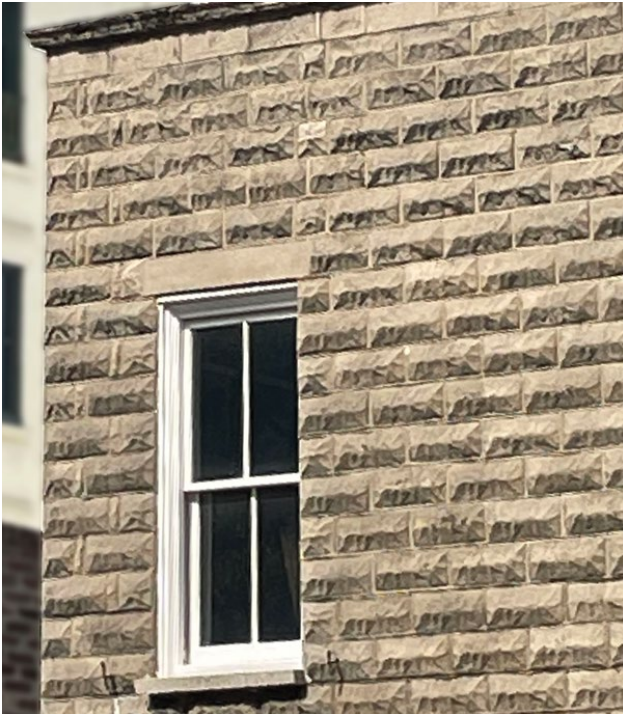
Figure 2a. Casting concrete blocks to mimic quarried stone was a popular late 19th- to mid 20th-century technique. Concrete masonry units could be completed by local craftsman, saving time and shipping costs. Photo: John Sandor, NPS.

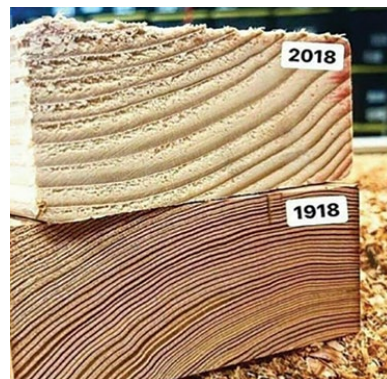
Figure 6. The dramatic difference in the number of growth rings between old-growth wood and wood that was recently harvested from second- or third-growth forests is indicative of the diminished dimensional stability and durability of most lumber currently available. Photo: Zachary Dettmore.

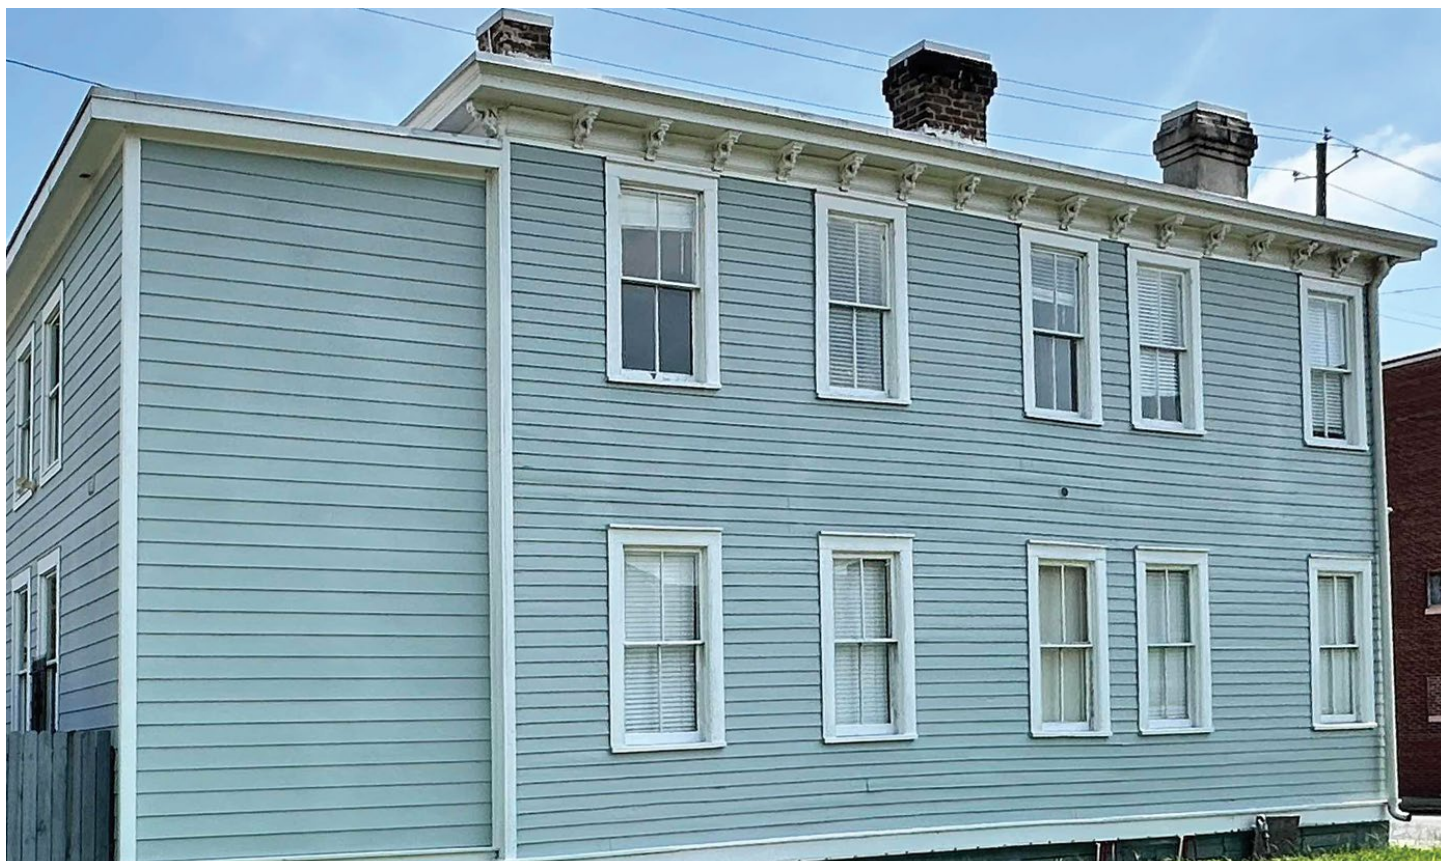
Figure 7. A new addition replaced non-historic construction on the rear elevation of this building. Fiber cement gives the addition a compatible appearance without replicating the exposure for thickness of the historic siding. Photo: Ward Architecture + Preservation.

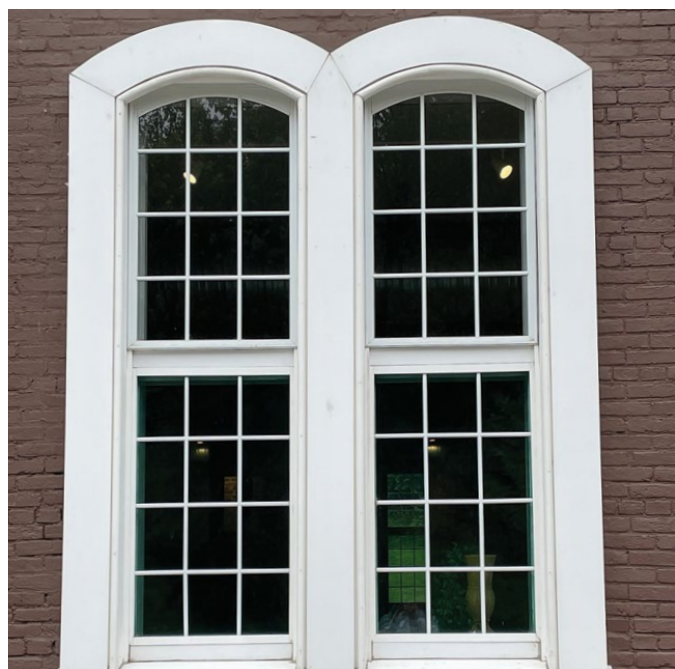
Figure 9. Previously bricked-in openings below the flood line were reopened and new aluminum windows installed with cellular PVC trim detailed to hold back moderate flood waters and survive exposure to water. Photo: John Sandor, NPS.

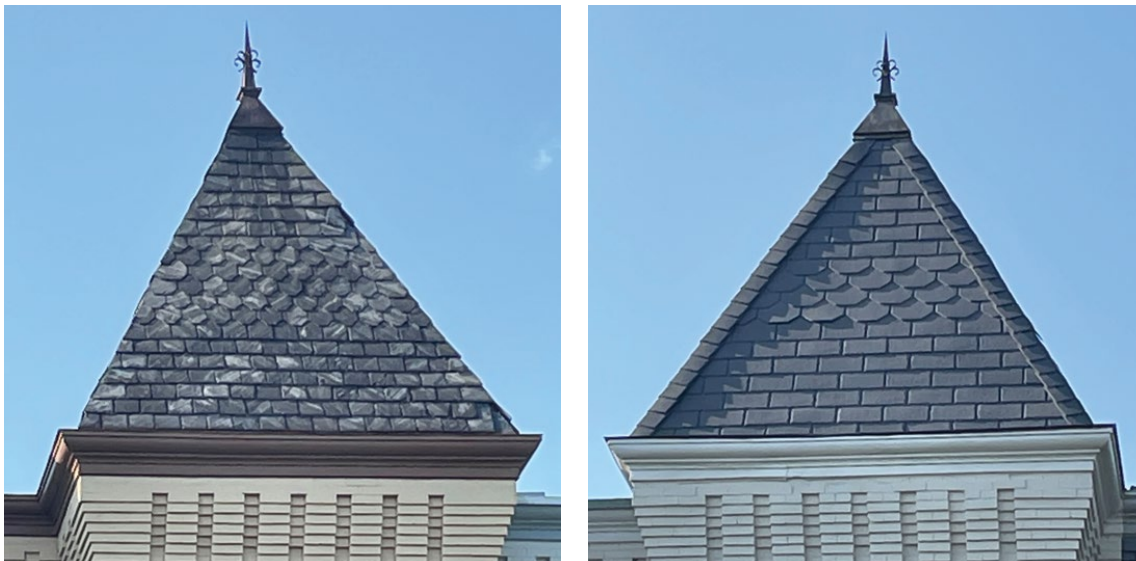
Figure 10. Polymer slates offer a choice of shapes but not sizes, limiting their ability to achieve a good visual match for some historic slate. With the size of the polymer slates (right) being nearly twice that of the historic slates (left), the scale of the entire feature is incompatibly altered. The molded edges of this material, which contribute to its ability to replicate slate, would be lost if each shingle was resized by cutting. Photo: John Sandor, NPS.

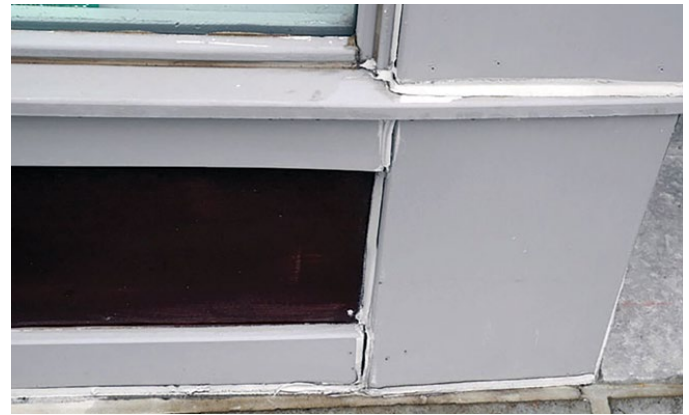
Figure 12. Cellulose composite materials, like wood, expand and contract with moisture. Here it was used to reconstruct a missing storefront. Unlike solid wood that is dimensionally stable parallel to the grain, this composite moves equally in all dimensions, resulting in gaps that were not adequately anticipated in the design. Photo: John Sandor, NPS.

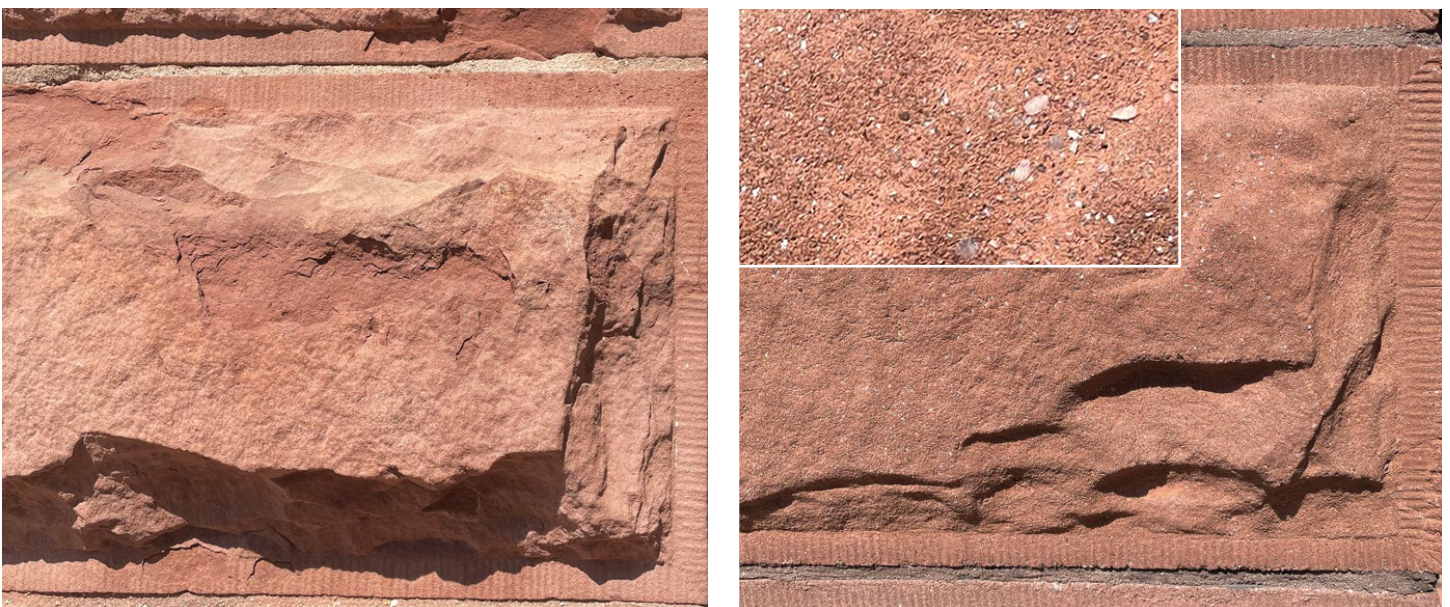
Figure 13. Cast stone was used to effectively replace individual blocks of sandstone. Both the original (left) and the substitute material (right) retain similar physical and visible properties. Having weathered for over 30 years, some erosion of the binder has revealed quartz grains of the aggregate (inset), but it is only noticeable upon close inspection. Photo: John Sandor, NPS.

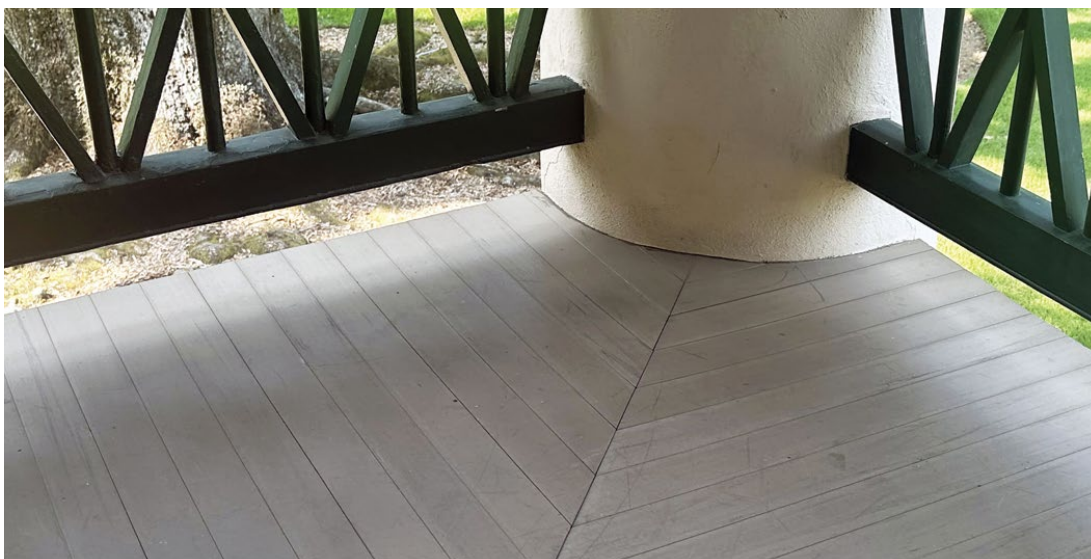
Figure 15. Tongue-and-groove porch flooring is manufactured in several different substitute materials. Each type has different properties, though most are more moisture-resistant than wood. The prefinished product shown can be painted when worn, but repainting is not recommended for some product choices. Photo: Oak Alley Foundation.

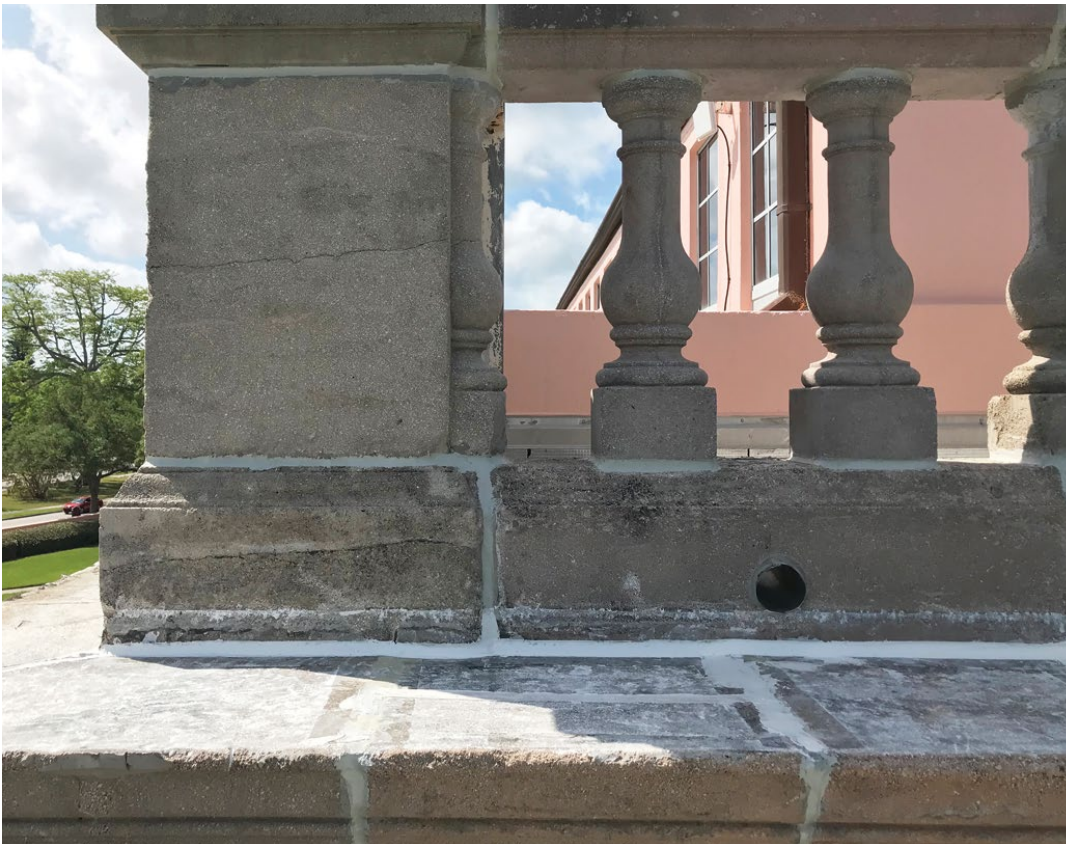
Figure 17. The balustrade consists of multiple prior campaigns of using cast stone to replace the natural stone. The effective match for the surface texture and color of the original stone allowed individual elements to be incrementally replaced only when they had failed, thus retaining the maximum amount of original material as long as possible. Photo: EverGreene Architectural Arts.

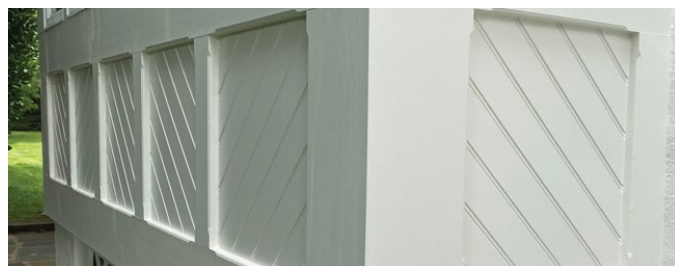
Figure 24. Cellular PVC when painted can be used to replace deteriorated wood features. This beadboard set in a wood frame was not historically designed to shed water effectively and had deteriorated. Cellular PVC was able to match the appearance of the wood details, while its properties were well matched to the shady location, painted finish, and limited size and configuration within the overall assembly; thus, it should provide a long-lasting solution for this application. Photo: Jennifer Balson Alvarez, NPS.
